**CONSTRUCTION QUALITY AUDIT OF
UNDER CONSTRUCTION CGEWHO HOUSING
PROJECT (PH-III)
KOLKATA, WEST BENGAL**

Umesh Kumar Sharma, Professor

**Department of Civil Engineering
Indian Institute of Technology Roorkee
Roorkee, 247667
(April 2025)**

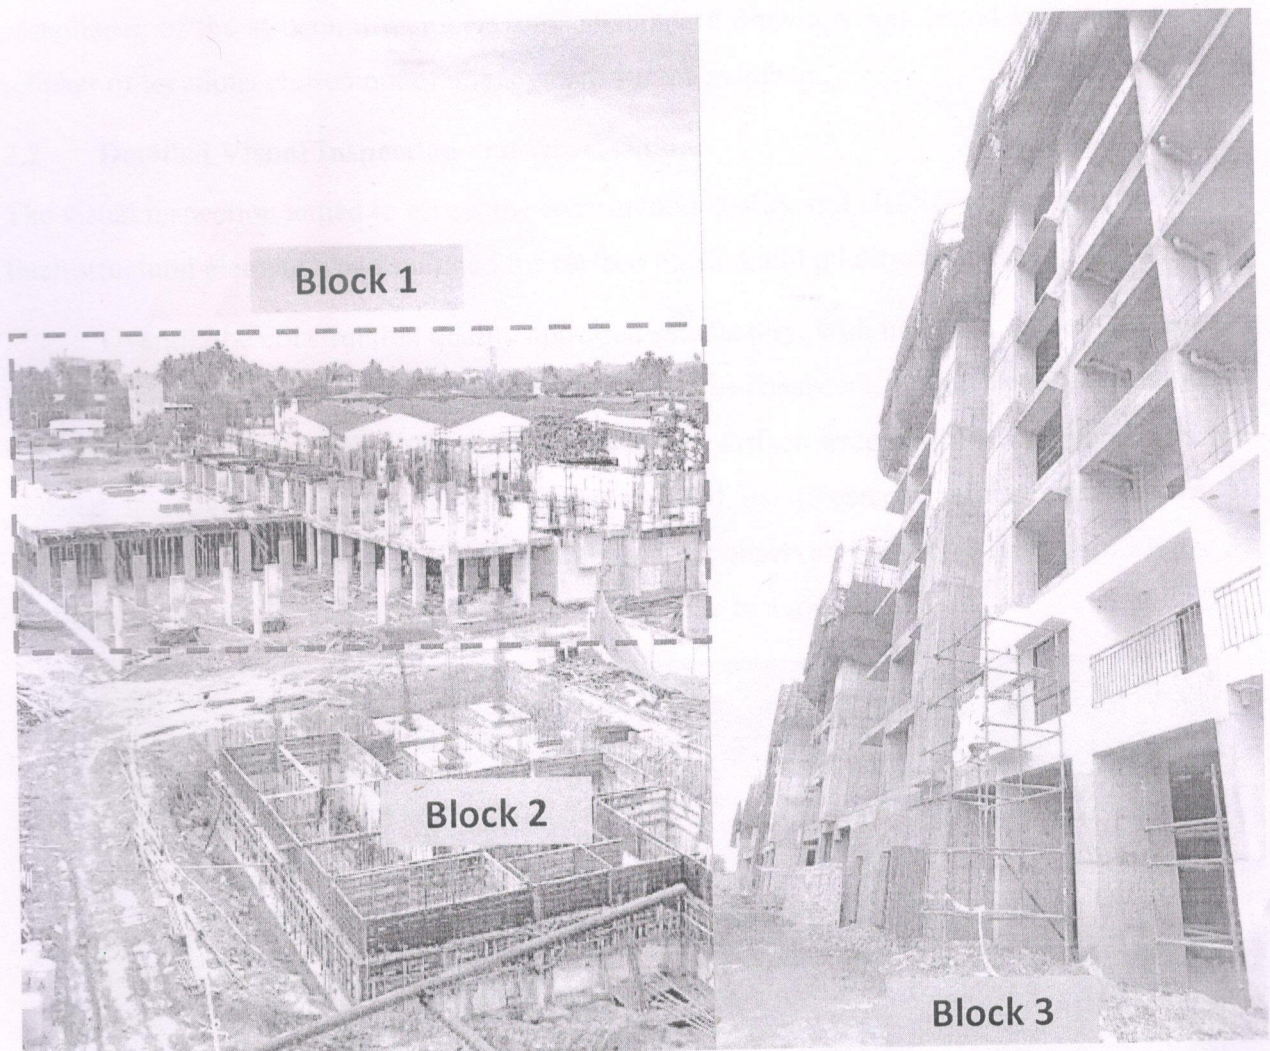
Figure 1: Construction status of CGCWHO Housing Project Blocks

As of the assessment date, construction progress varied across the blocks. In Block 1, the ground floor of the Pile Zone had been completed, whereas the columns for the Non-Pile Zone were

constructed in February. In Block 2, the foundation work was already completed, and the plinth beam construction was in progress. In Block 3, progress was recorded at different levels—Part 1 had reached the sixth floor, Part 2 had been cast up to the fourth floor, and Part 3 had progressed up to the second floor.

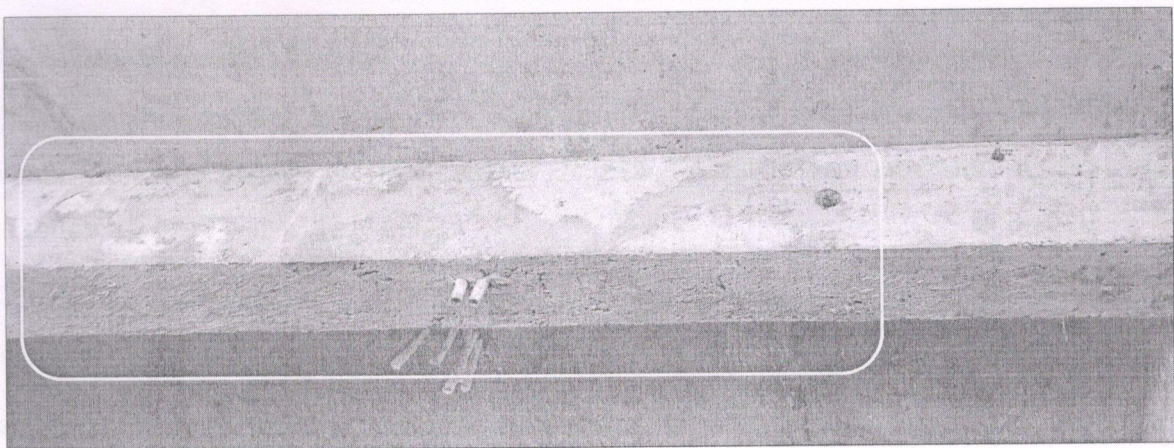
Overall, the construction quality appeared satisfactory, with no major defects observed in the completed structural elements. The surface finish was consistent, and no significant anomalies were identified across the buildings. However, minor surface irregularities were noted at a few isolated locations, which had already been rectified using cement mortar (see **Figure 2**). Additionally, isolated instances of honeycombing were observed in Block 3 (shown in **Figure 3**). Necessary instructions and advice were given at the site to avoid them.

Figure 2: Few Instances of Anomalies in surface finishing

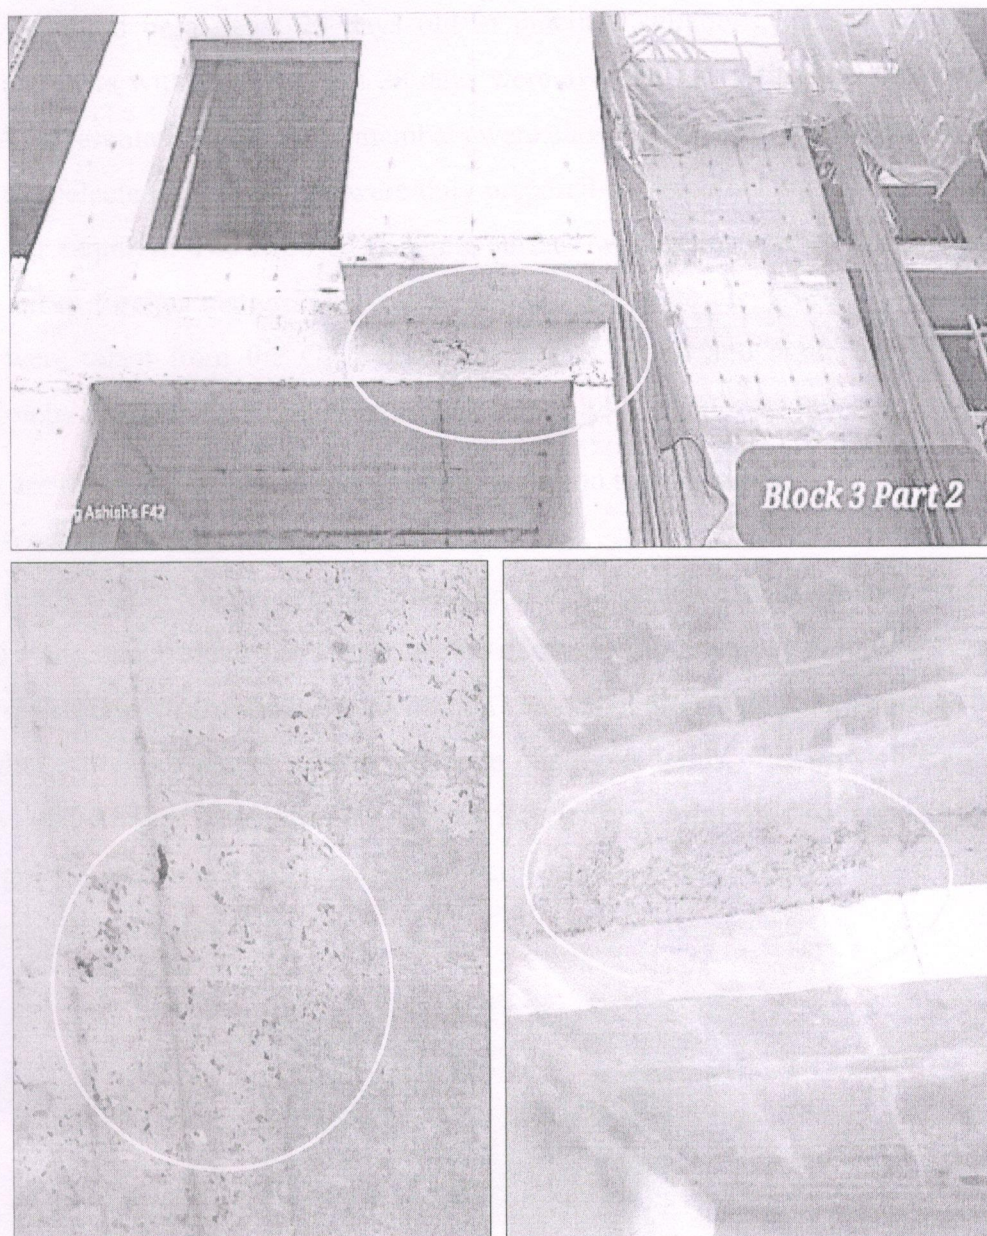
Figure 3: Honeycombing issues at isolated locations in Block 3

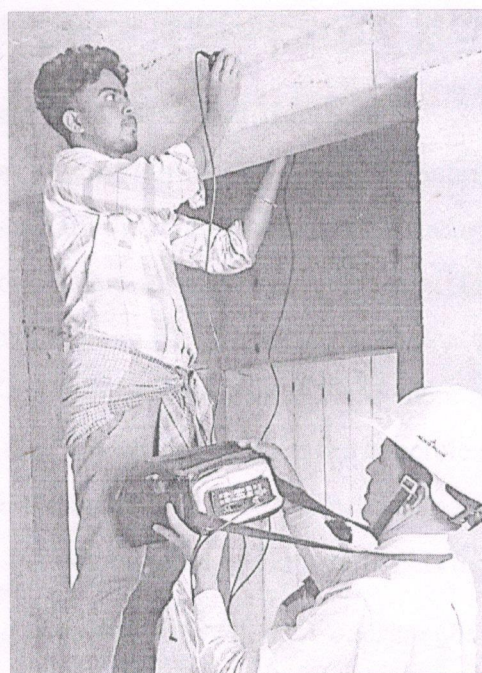
Figure 4: Typical view of Ultrasonic Pulse Velocity Test in Progress

According to project documentation, M30-grade concrete has been used in the ongoing construction. The test results indicate that the concrete quality at all tested locations falls within the "good" to "excellent" range, with UPV values varying between 3.78 km/s and 4.58 km/s, and an average value of 4.14 km/s. Although minor overestimation of UPV readings may occur due to residual moisture in the concrete, the overall values confirm the sound quality of the concrete. These findings align with the visual inspection, where the concrete elements were observed to be mostly free from any noticeable distress or defects.

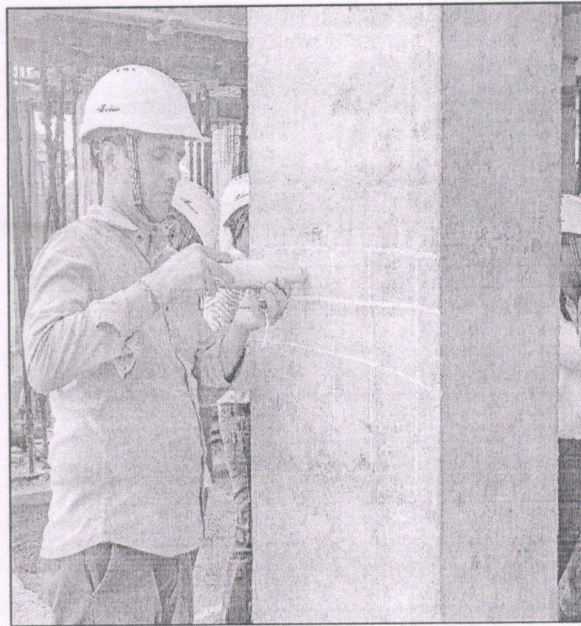
Figure 5: Typical view of Rebound Hammer Test in Progress

Since construction was very new, negligible carbonation is expected. This makes rebound hammer test a reliable indicator of concrete surface quality. In the present case, the rebound hammer values vary between 38 to 52, indicating good to very good concrete surface quality. Such a high value also exhibits that concrete was free from patches or delamination.
